Home Inspection Report

641 E. Holland Dr
Bloomington, IN 47401

Prepared For: Owen Kinney
Inspected On Thu, Jun 23, 2022 at 9:15 AM

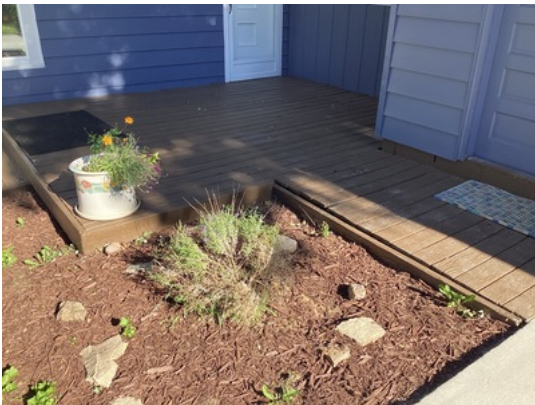
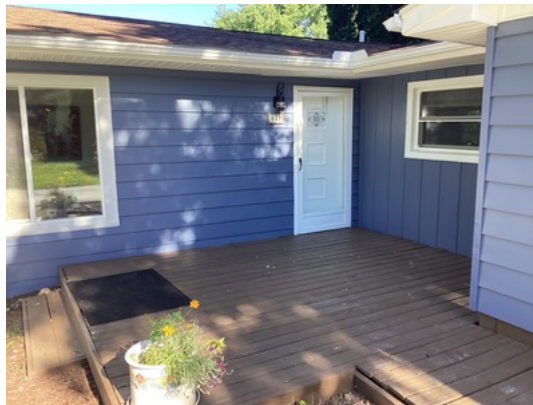
Loose deck boards on front porch. Few boards will need replacement.

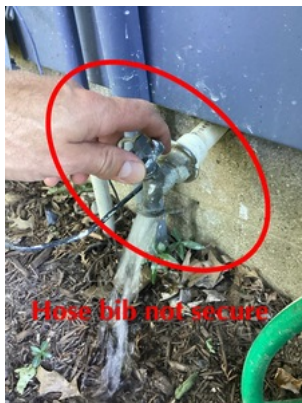
Rear hose bib not secured to wall. Water line is loose. Recommend securing.

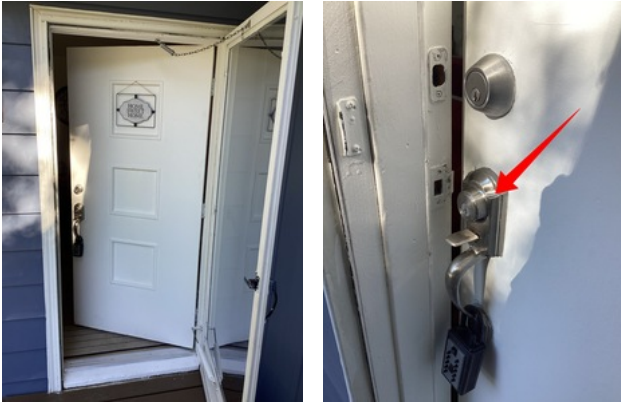
Front entry door does not secure properly. Lock not functional. Deadbolt only. Recommend repair.

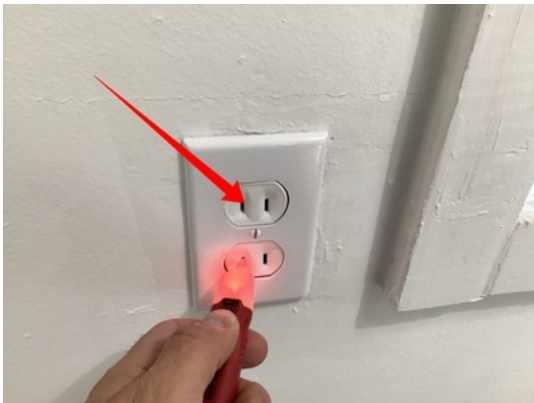
No verifiable GFCI protection for garage receptacles. Receptacles are ungrounded. Recommend adding GFCI receptacles for proper protection.

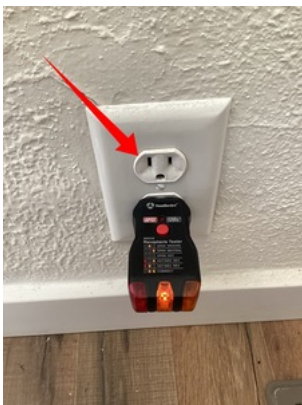
Ungrounded receptacles with three prong covers in living room. Recommend replacing with two prong ungrounded receptacles.

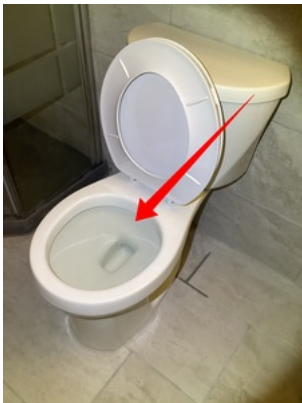
Master bath toilet does not flush properly. Bowl filling with water. Recommend repair by professional plumber.

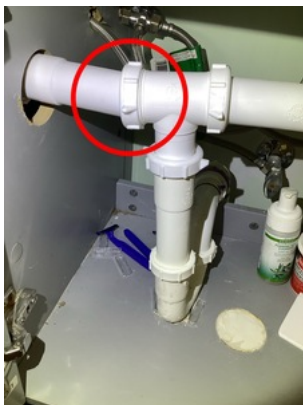
Slow water leak under first floor bath sink due to bad plumbing joint connection. Recommend repair.

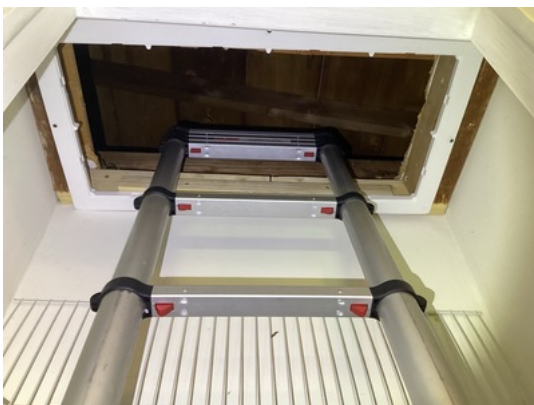
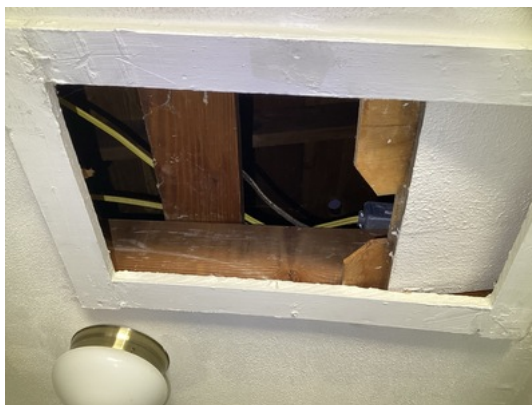
Access limited to attic hatch in closet due to small opening. Garage attic not accessible due to small hatch blocked by framing and wires.

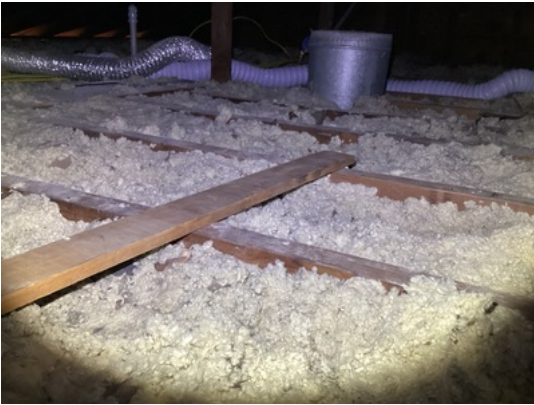
Attic insulation was marginal. Visible ceiling joists. Recommend adding additional insulation to improve energy efficiency.

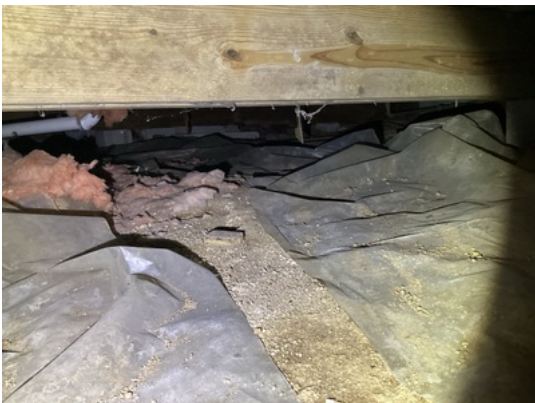
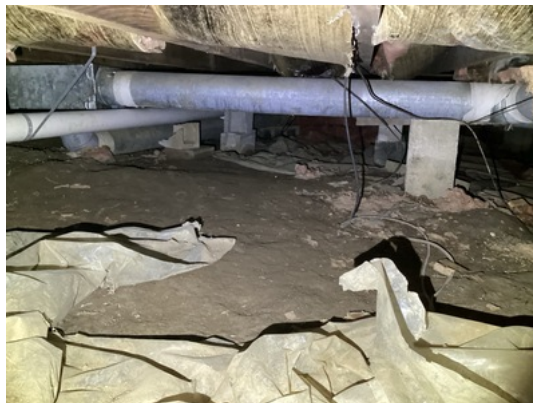
Improperly Installed

Missing vapor barrier. Improperly installed.

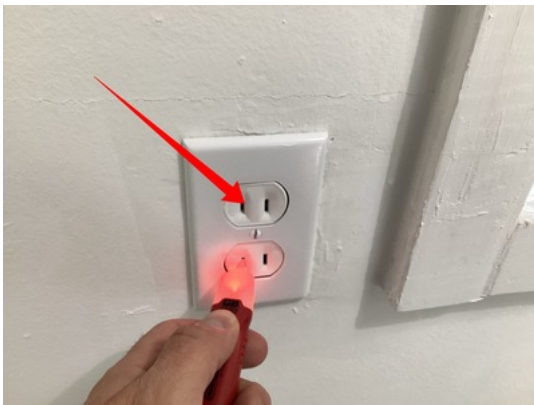
No verifiable GFCI protection for garage receptacles. Receptacles are ungrounded. Recommend adding GFCI receptacles for proper protection.

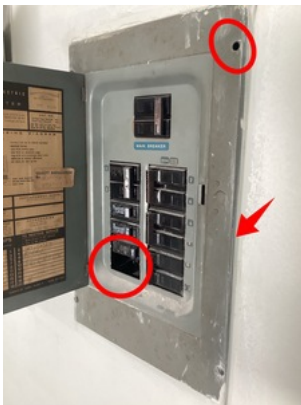
Panel cover not removed. Cover was sealed shut. Missing panel cover screw. Missing knockout. Recommend further evaluation and repair.

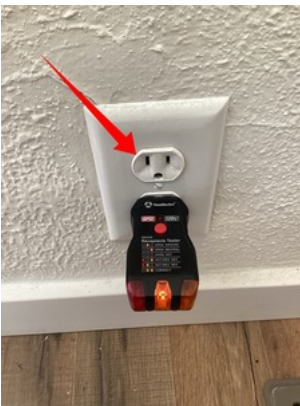
Ungrounded receptacles with three prong covers in living room. Recommend replacing with two prong ungrounded receptacles.
