Home Inspection Report

641 E. Holland Dr
Bloomington, IN 47401

Prepared For: Owen Kinney
Inspected On Thu, Jun 23, 2022 at 9:15 AM

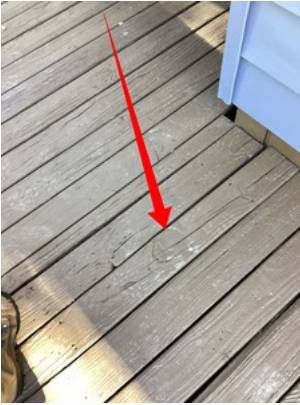
Loose deck boards on front porch. Few boards will need replacement.

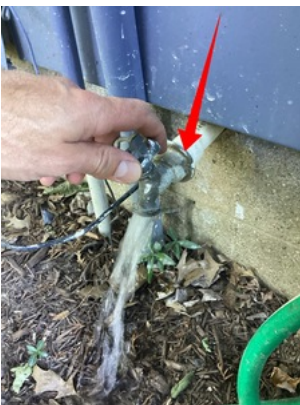
Comment 5
Repair or Replacement Needed

Rear hose bib not secured to wall. Water line is loose. Recommend securing.

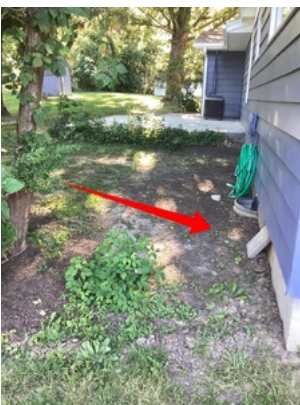
Comment 6
Monitor Condition

Rear grading is sloped towards house. Recommend monitoring during heavy rain.

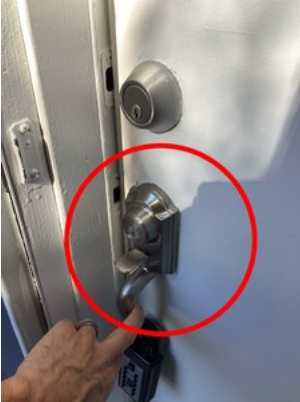
Comment 7

Repair or Replacement Needed

Front entry door does not secure properly. Lock not functional. Deadbolt only. Recommend repair.

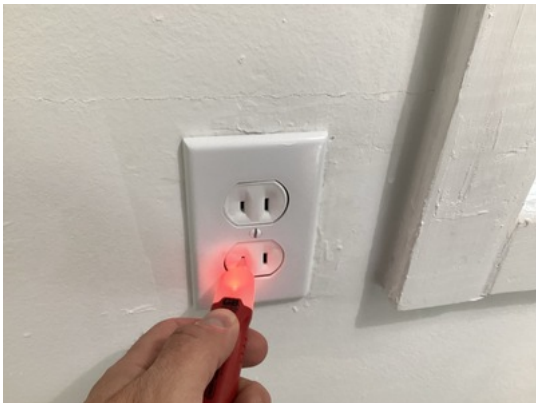
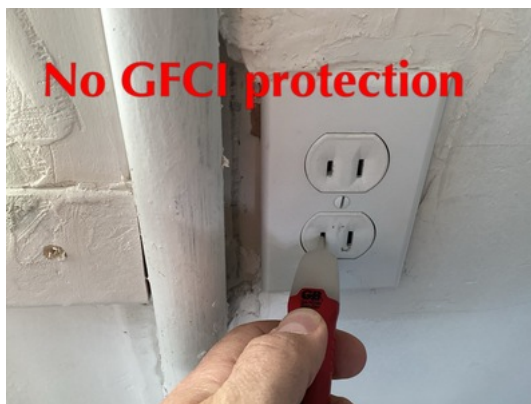
Electrical Receptacles

Receptacles Present, No verifiable GFCI protection, Ungrounded receptacles

No verifiable GFCI protection for garage receptacles. Receptacles are ungrounded. Recommend adding GFCI receptacles for proper protection.

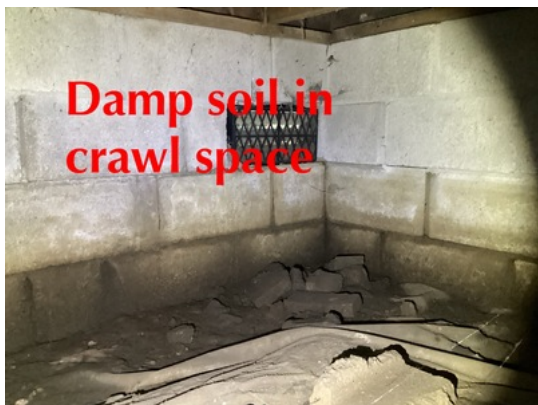
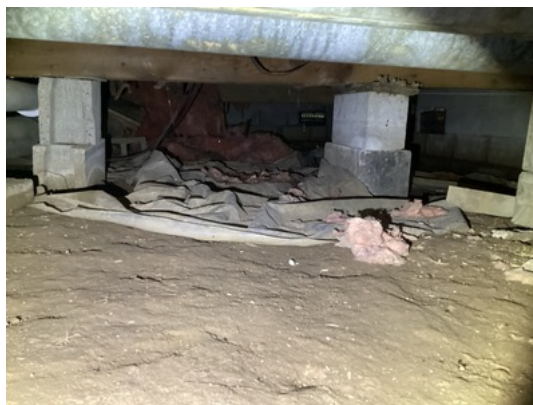
Damp soil

Condition: Marginal

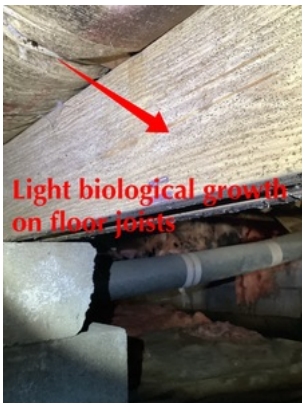
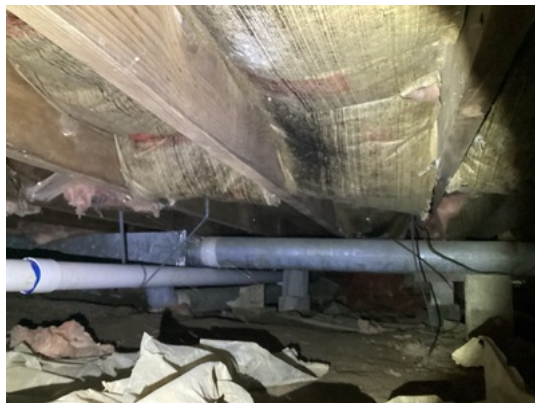
Joists

Condition: Marginal

Light biological growth visible on floor joists in crawlspace. Recommend remediation.

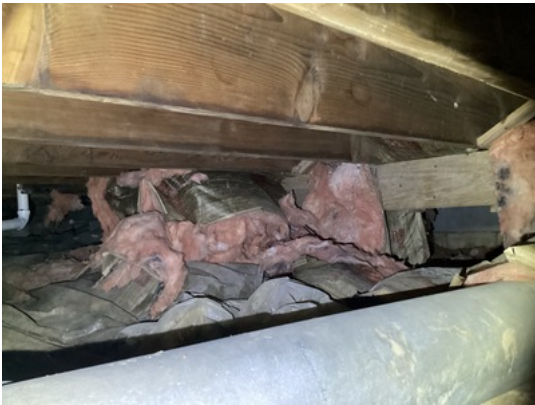
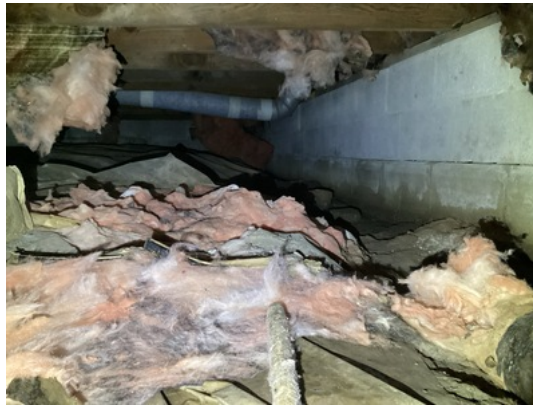
Insulation

Old fiberglass insulation has fallen and should be removed.

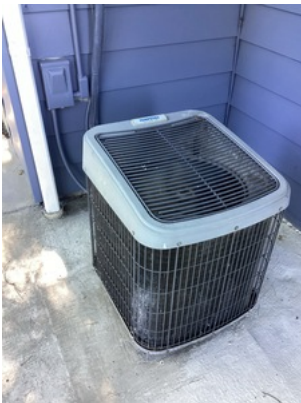
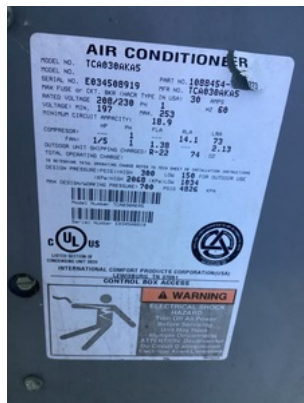
Photo of Condenser And Dataplate

Exterior A/C condenser unit is aging at 19 yrs old. Recommend regular service to prolong life of unit.

Air conditioners over 10 years old and heat pumps over 5 years old should be checked, cleaned and serviced yearly by a licensed contractor.

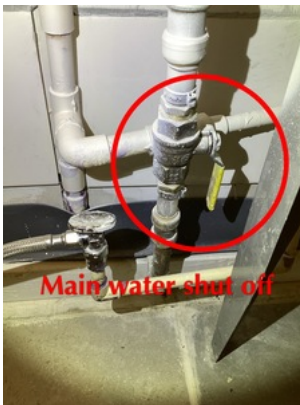
Location of Main Water Shutoff

Garage bath

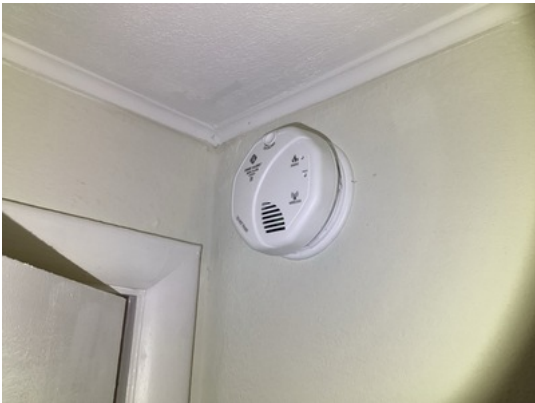
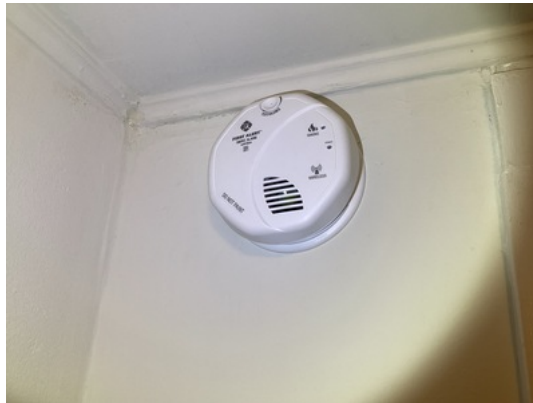
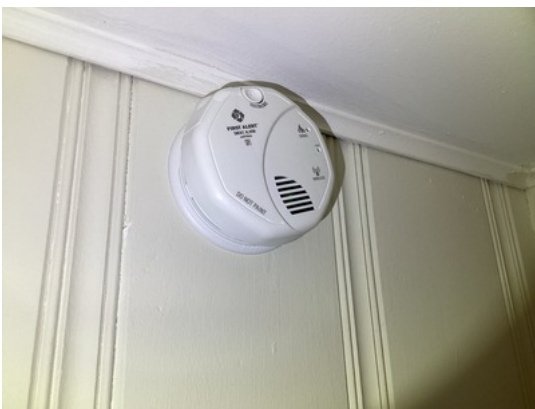
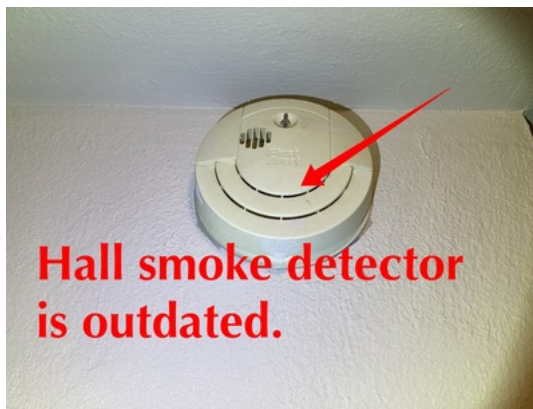
Smoke / CO Detectors

**Hall smoke detector
is outdated.**

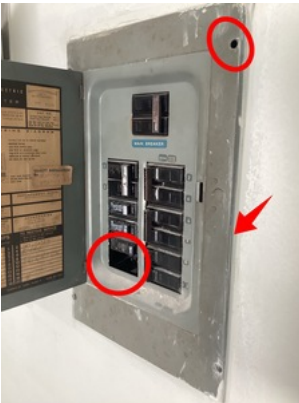
Panel cover not removed. Cover was sealed shut. Missing panel cover screw. Missing knockout. Recommend further evaluation and repair.

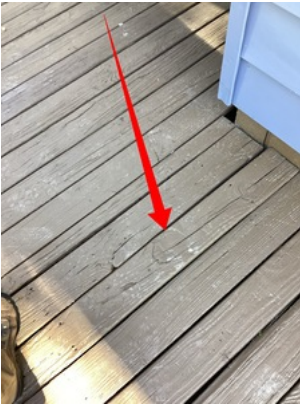
Grounds

Loose deck boards on front porch. Few boards will need replacement.

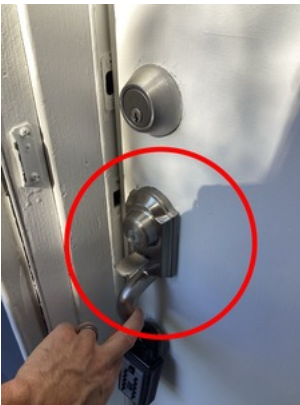
Exterior

Front entry door does not secure properly. Lock not functional. Deadbolt only. Recommend repair.

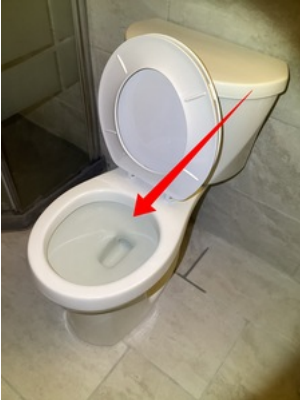
Master Bathroom

Master bath toilet does not flush properly. Bowl filling with water. Recommend repair by professional plumber.

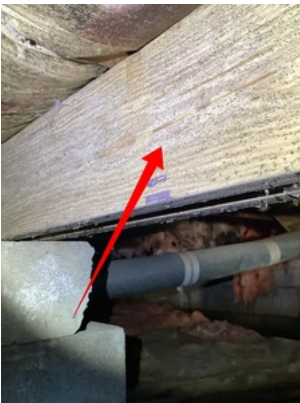
Crawlspace

Light biological growth visible on floor joists in crawlspace. Recommend remediation.

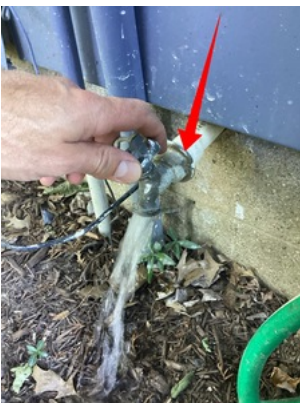
Grounds

Rear hose bib not secured to wall. Water line is loose. Recommend securing.

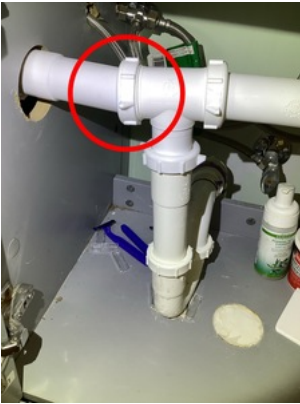
Bathroom 1

Slow water leak under first floor bath sink due to bad plumbing joint connection. Recommend repair.
